One Hundred Years Settlement of the Verna's Breakwater - Construction on Soft Clay Like a Typical Example from University Program of Port Construction in Bulgaria

Chavdar Vassilev Kolev
"Perikal 2003" Ltd., Sofia, Bulgaria

ONE HUNDRED YEARS SETTLEMENT OF THE VERNAL BREAKWATER - CONSTRUCTION ON SOFT CLAY LIKE A TYPICAL EXAMPLE FROM UNIVERSITY PROGRAM OF PORT CONSTRUCTION IN BULGARIA

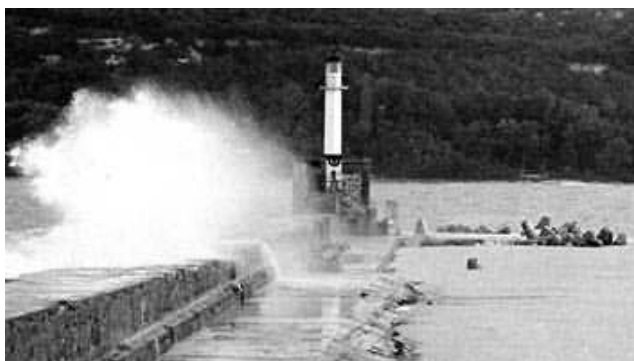
Fig4. The breakwater and the lighthouse (Pharr)

An entrance lighthouse was constructed at the end of the breakwater. It has white light, stopping every three seconds. A

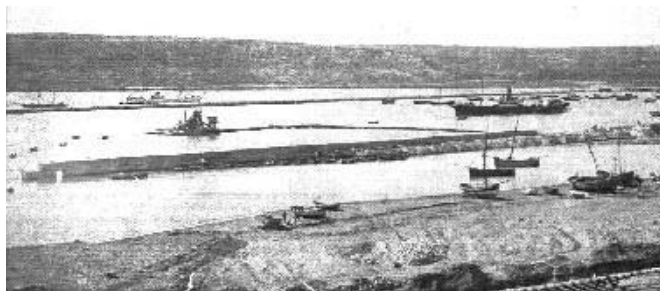
The construction started in 1895 and, according to the contract, had to be completed in 1901 (Fig.7). Due to financial reasons the construction continued until 1906.

Fig7. Embankments on the New Port Varna (1896-1900)

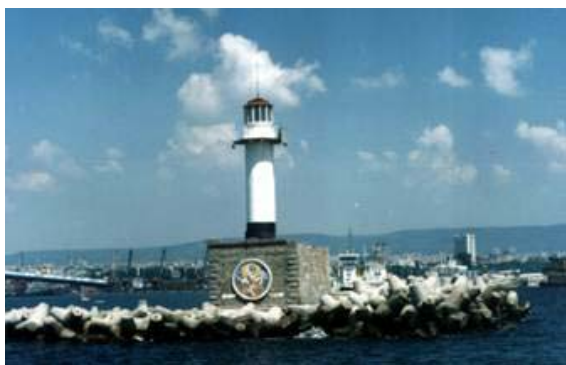
Fig12. Protection by tetrapodes (2007)

Currently the breakwater is undergoing a reconstruction. Since the construction of the breakwater, only one the body was made about 25-30 years ago when tetrapods (Fig.12) were arranged in the most critical sections of the outer batter.
